# **Fatigue of Composite Material Beam Elements Representative of Wind Turbine Blade Substructure**

John F. Mandell, Daniel D. Samborsky,  
David W. Combs, M. Ethan Scott,  
Douglas S. Cairns  
*Department of Chemical Engineering  
Montana State University  
Bozeman, Montana*

November 1998

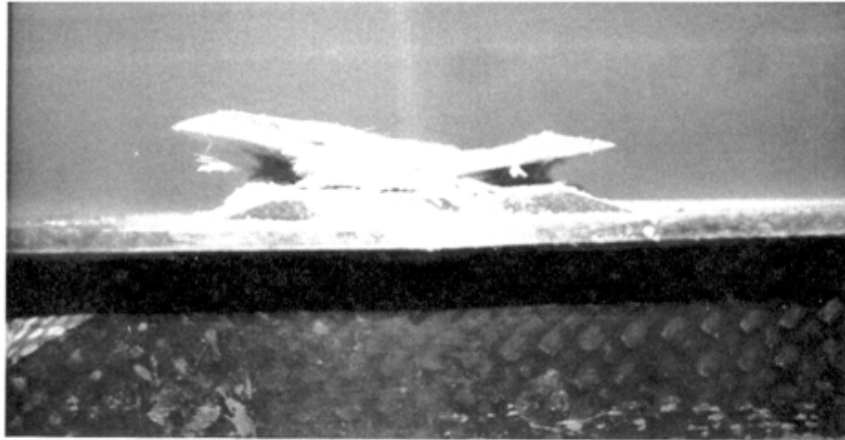
**Figure 12. (a) Load pad damage and compression damage zone, tension side of Beam 1.  
(b) Adhesive failure of Beam 2.**

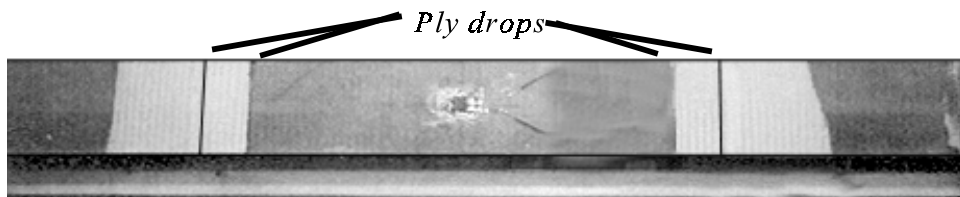
**Figure 14. Delamination of ply drops, beam 3.**

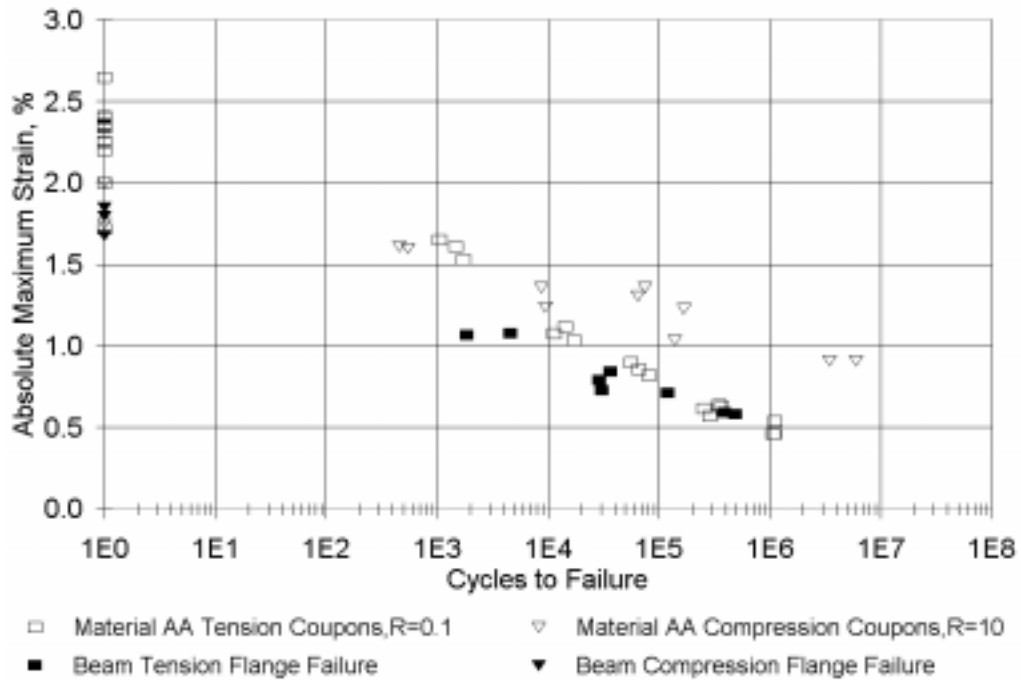
Figure 31(a) compares the failure strain conditions for the AA flange beams with the strain-cycles data for the material AA coupons. (The solid square and triangle symbols are the measured initial strains on the tension and compression flanges, respectively; the symbol shown indicates which flange actually failed.) The static beam tests (6, 9, and 13) resulted in compressive flange failures

with damage in the web as well (Figure 31(a)). The measured static compressive flange strains at failure cover the range observed for the compressive coupon tests (Figure 31(a), one cycle). Figure 31(b) compares the web material CH10 coupon results with the beam data; the CH10 tensile fatigue strains are, again, similar to the beam failure strains. In order to compare coupon data with web flange strains in the beams, the beam strains are adjusted downward to 0.82 of the measured flange outside surface strains to give the strain at the outside of the web flange (assuming a linear strain variation across the beam depth).

We conducted fatigue tests with beams having the AA material flanges (without holes) for beams 7, 8, 9, 10, 11, 12, and 14. These beams all failed on the tension flange, and the results in Figure 31(a) show close agreement with the failure strains and cycles for tensile coupons of the same material, tested at  $R = 0.1$  (the same  $R$  value as the beam tensile flange). The predicted shift from compressive failure at low cycles to tensile failure at high cycles is observed in the beam results only in the static compression failures compared with tensile fatigue failures; no lifetimes could be produced in fatigue between 1 and 1,000 cycles because of difficulties in controlling tests in the low cycle range. Photographs of failure details are given in the Appendix for most beams, and Figures 32 and 33 gives a combined photograph of all flanges in this series as well as several detailed photographs.

The overall results provided in Figure 31 validate use of the fatigue coupon database to predict beam structural-element lifetime for tension-dominated failures. Earlier discussion showed that the beam strains are accurately predicted by appropriate finite-element analysis, with a reasonable approximation by simple beam theory. Thus, when analyzed appropriately, the results given here confirm that these materials, when fabricated into a structural element similar to a blade, provide the static strength, tensile fatigue lifetime, and failure mode anticipated from simple coupon data. The size, flexural loading, and bonding to the web element do not compromise or complicate the material performance.

Figure 31(a). Beams 6 - 14, 22 and 23 with material AA flanges and material CH10 web compared with material AA coupon fatigue data.

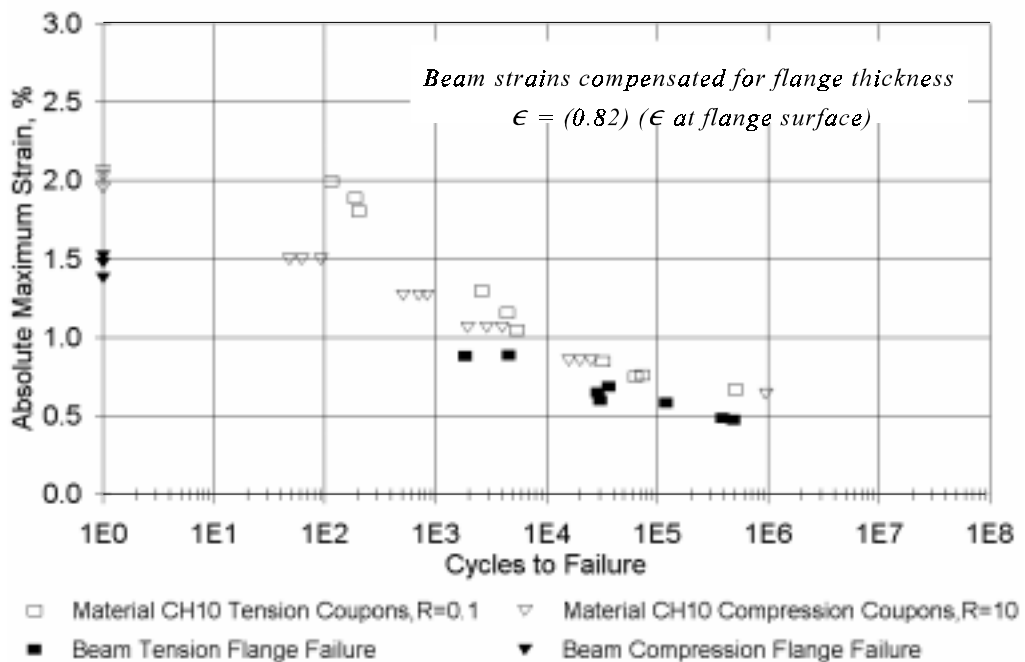
Figure 31(b). Beams 6 - 14, 22 and 23 with material AA flanges and material CH10 web Compensated for flange thickness compared with material CH10 coupon fatigue data.

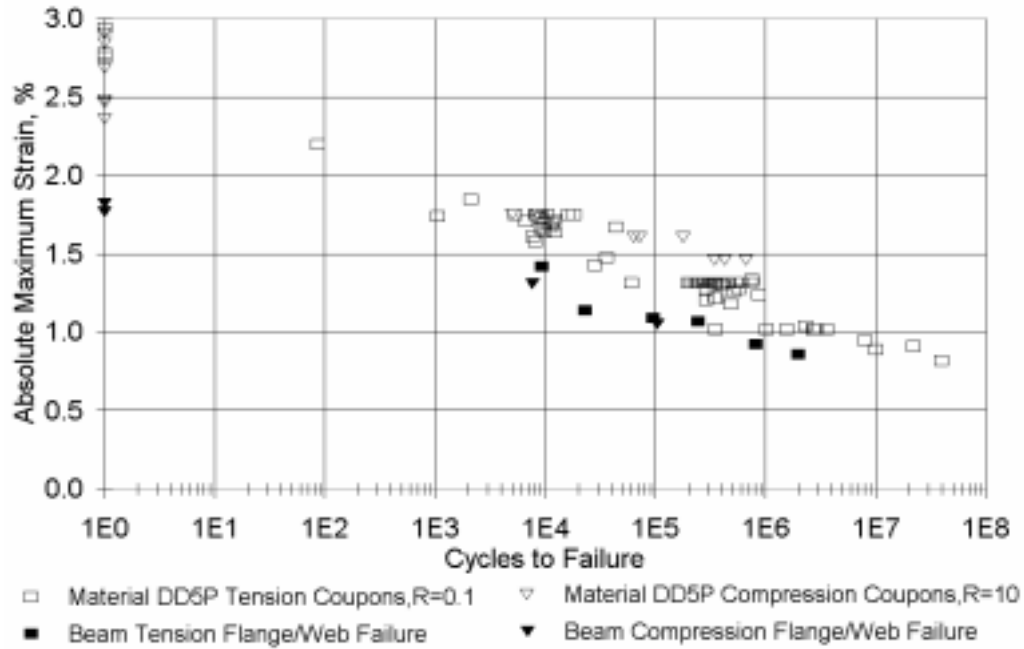
Figures 34 and 35 compare the beam data with flange material and web material coupon data, respectively. All of the failures were predominantly in the web, with some flange interaction. The results in Figure 35 show that the web flanges should have already cracked heavily prior to flange failure, and this appeared to be the case. Thus, most of these failures were induced in the web flange area, and agree generally with the web coupon data in Figure 35. Significant flange-web delamination near the ends of the shear stiffeners was also observed, as shown in Figure 36.

Figure 34. Beams 18 - 21 and 24 - 29 with material DD5P flanges and material CH10 web compared with material DD5P coupon fatigue data.

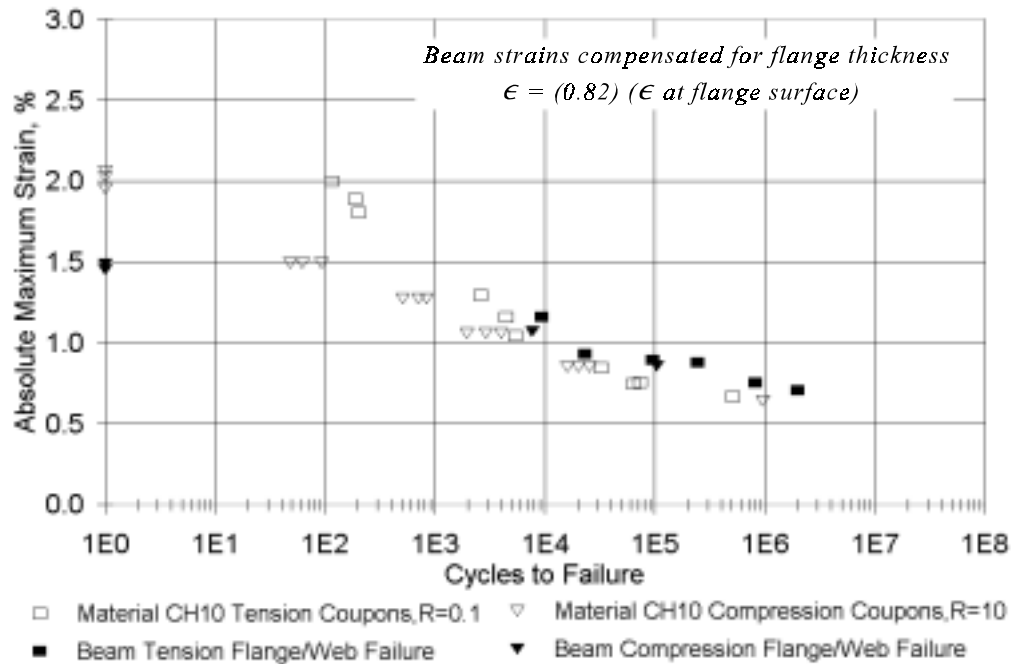
The results with web material CH10 were disappointing, in that failures predominantly generated from the web flange area. We decided to test several web materials with strain capability that more nearly approximated the flange material (DD5P), using the flange material itself in the web. Figure 30(a) compares the tensile strains of the four web materials tested in tensile fatigue. Higher  $0^\circ$  material content gives higher tensile fatigue strain capability if the overall fiber content is similar.

Figure 35. Beams 18 - 21 and 24 - 29 with material DD5P flanges and material CH10 web compensated for flange thickness compared with material CH10 coupon fatigue data.

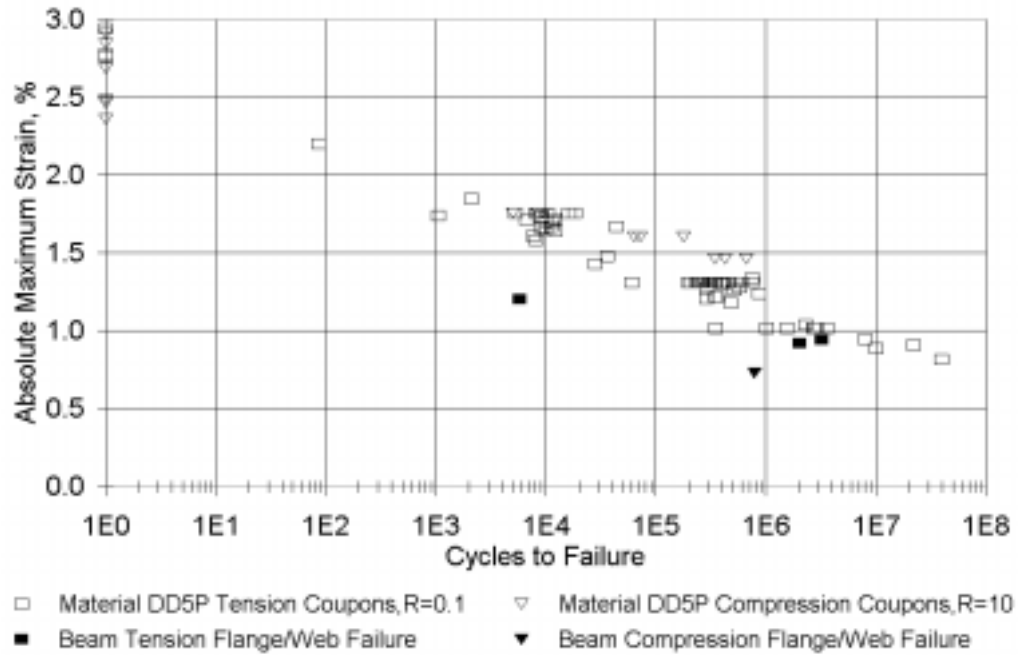
Table 18 gives the results for beams with DD5P flanges and CH3, CH12, and DD5P webs. Figures 37 and 38 give the DD5P flange/CH3 web results for beams 30-33 compared with flange and web coupon data respectively. All of the beams in this group showed a variety of delamination and web damage. The beam data in Figures 37 and 38 agree generally with the flange and web coupon data,

**Figure 37. Beams 30 - 33 with material DD5P flanges and material CH3 web compared with DD5P coupon fatigue data.**

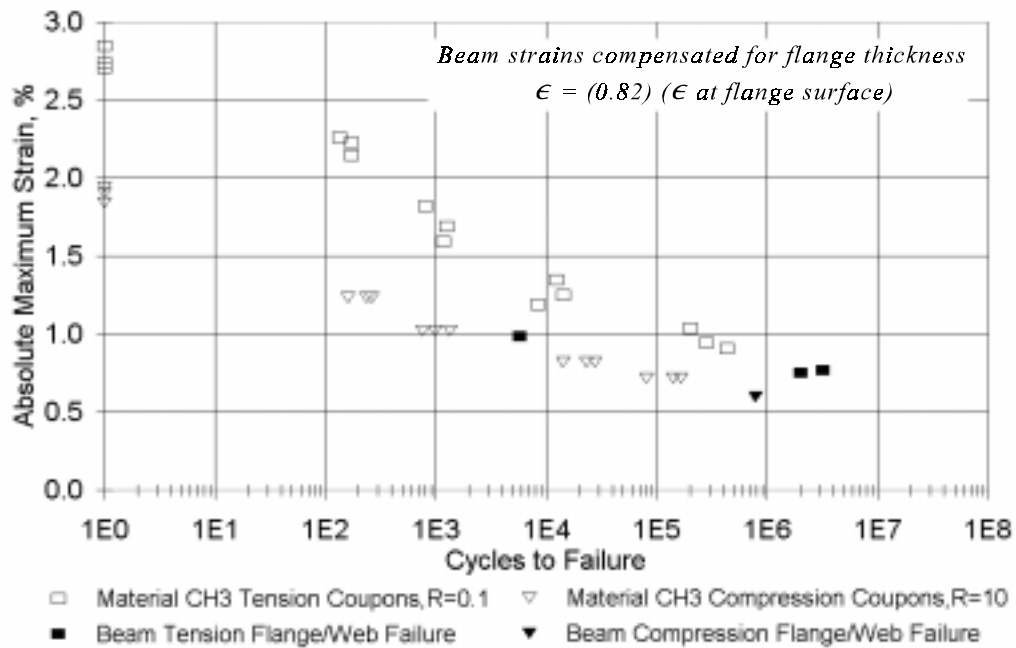
**Figure 38. Beams 30 - 33 with material DD5P flanges and material CH3 web compensated for flange thickness compared with CH3 coupon fatigue data.**

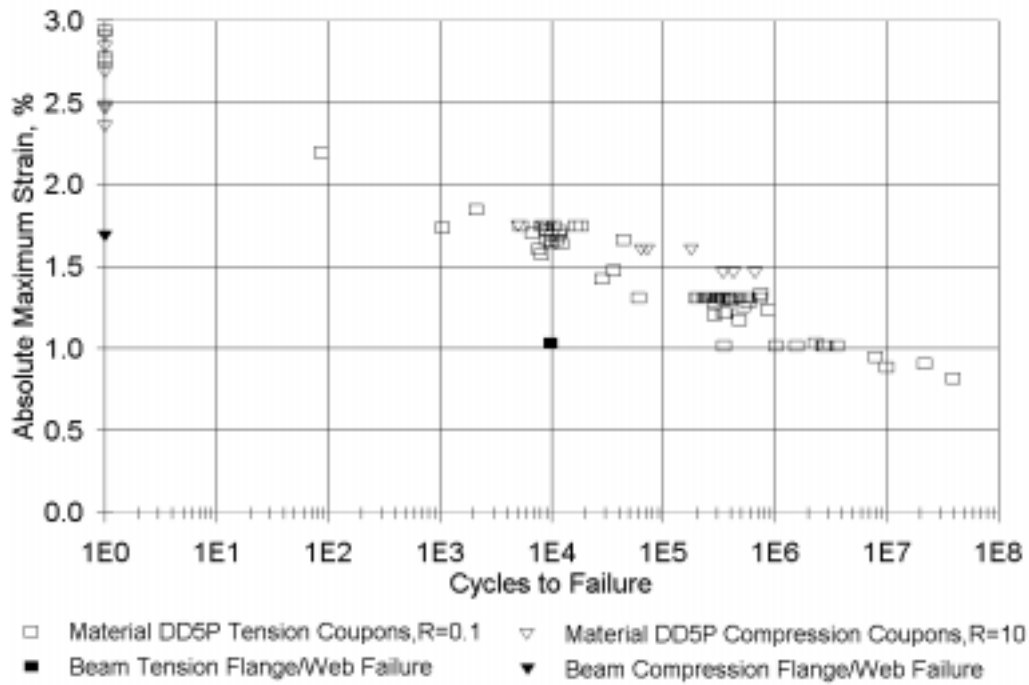
Beams 34 and 35 included DD5P material flanges and CH12 web material (see Table 18 and Figures 39 and 40). As indicated in Table 18, these beams produced delamination failures in the load transfer area of the load pads. The fatigue failure (beam 35) was at a strain well below either set of coupon data, as expected from the load-transfer problems.

Figure 39. Beams 34 and 35 with material DD5P flanges and material CH12 web compared with material DD5P coupon fatigue data.

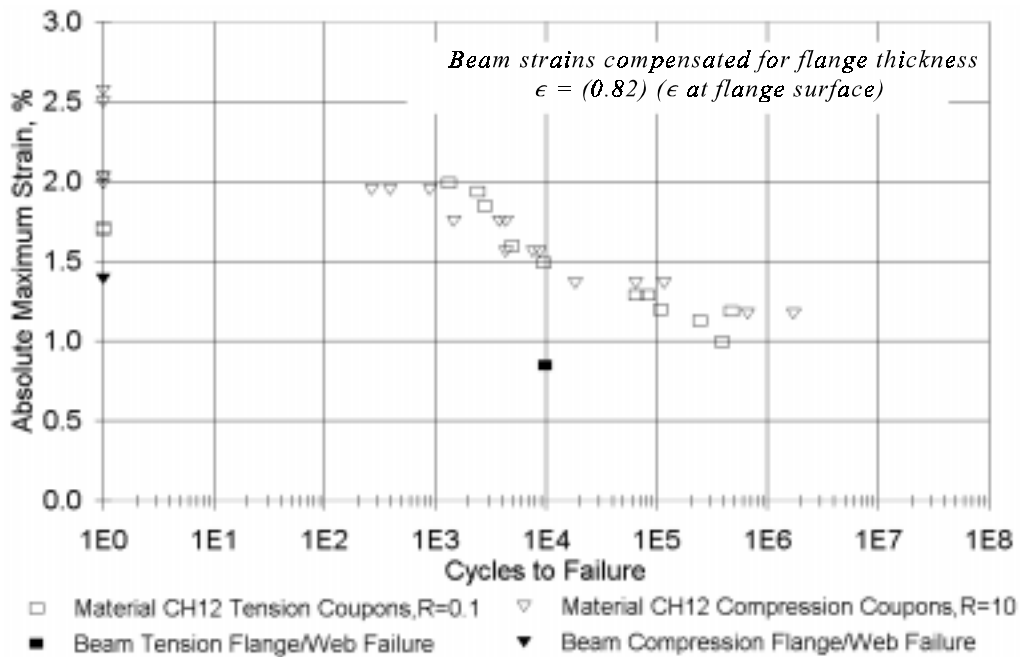
Figure 40. Beams 34 and 35 with material DD5P flanges and material CH12 web compensated for flange thickness compared with material CH12 coupon fatigue data.

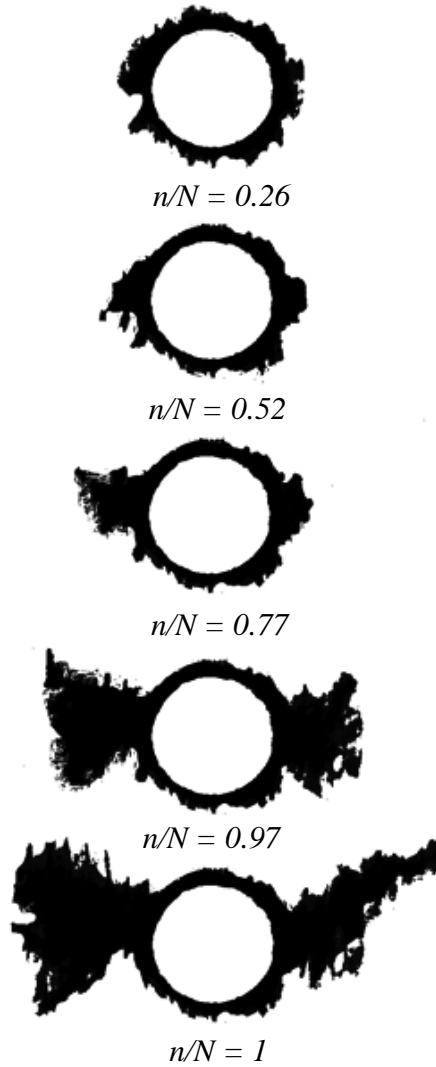
*Coupon 164AA*  
*103 Mpa,  $R = 0.1$*   
 *$N = 154,275$  cycles*

**Figure 44. Damage around the 13 mm diameter hole vs. fatigue lifetime.**

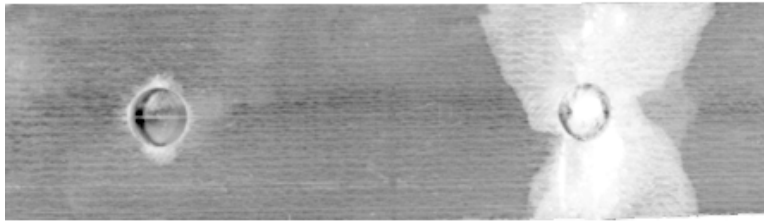
We fabricated three beams with several 13-mm-diameter holes drilled through both tension and compressive flanges (see Table 19). As expected, Figure 47(a) shows that the holes did reduce the static strength and fatigue life, relative to beams without holes. Figure 47(b) confirms that the beams behave similarly to the coupons containing holes. The static-tested beam (17) and the low-cycle fatigue beam (15) failed in compression, as expected from the coupon data, although at lower stress and higher cycles, the failure shifted to the tensile flange (beam 16). Again this is consistent with the coupon predictions. The mode shift is expected by comparing Figure 43(b) with 43(d). Figure 48 shows the details of failed beams with holes and other details as given in the Appendix.

*Beam 15 Compression flange*

*Beam 15 side view*

**Figure 48. Beam 15 with holes, static compression flange failure.**

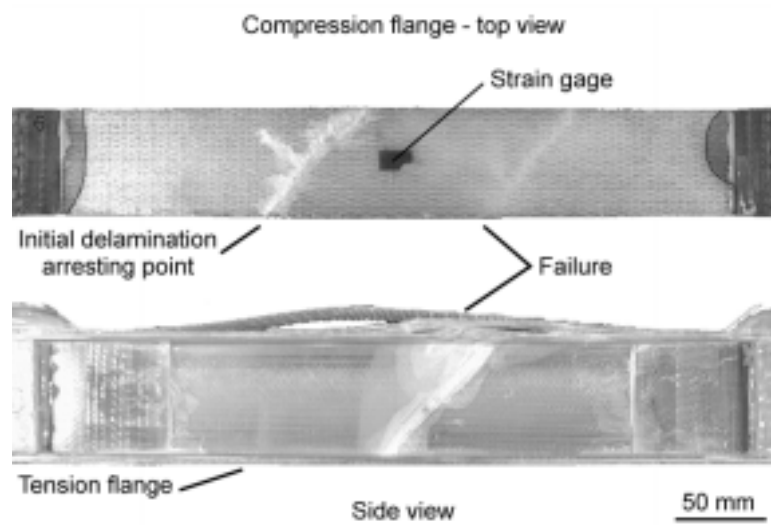
**Figure 58. Beam 6.**

Beam 6 was tested statically to failure. The beam was loaded under actuator displacement control at a rate of 0.25 mm/s until failure, which involved a total ramp time of 74 seconds. An initial beam stiffness of 3,711 kN/m was measured. As the beam was loaded, the compression flange started to twist along the X - axis, prior to final compressive failure of the compression flange. The total amplitude of this twist was approximated at 6 to 8 mm prior to failure and the onset of this twisting occurred at approximately 90 to 95% of the ultimate load. This twisting was also evident in the failed beam as one side of the beam flange had fragmented  $\pm 45^\circ$  strands pointing up, while the other side of the flange had the fragmented strands pointing down. Figures 58 and 59 show the failed beam. Further examination of the buckled compression flange indicated that the outside  $0^\circ$  ply (ply 3, Table 22) delaminated first from the adjacent  $+45^\circ$  layer (ply 4, Table 22). This delamination arrested at  $x = 267$  mm, which was evident by the white damage band in the outside plies at this point. It was not evident where the delamination started. From this initial arrest at  $x = 267$  mm, the delamination continued to grow towards both inside compressive load pads at  $x = 152$  mm and  $x = 464$  mm.

The web had multiple delaminations under the initial flange failure site generated after the flange failure. Some delamination spots are visible at  $x = 191, 267, 343$  and  $394$  mm, at the compression flange - web intersection that could be buckling nodal points. No shear stiffener, torsional stiffener or tension flange damage or delaminations were visible. The load - flange absolute maximum strain graph is shown in Figure 60 and indicates a maximum tension flange strain of 1.80% and a minimum compression flange strain of -1.6% which occurred at an ultimate applied load of 67.08 kN at a maximum mid-span deflection of 22 mm.

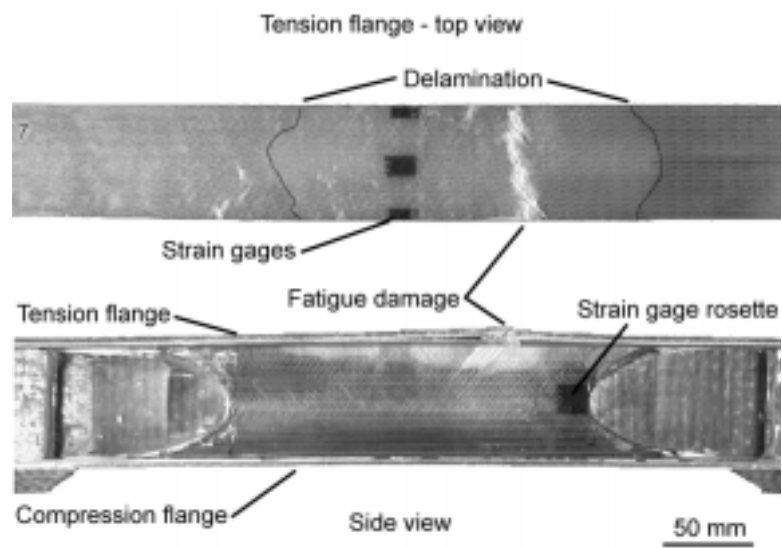
**Figure 66. Beam 7.**

As the fatigue test continued, the damage sites increased in size and some damage spots coalesced to form failure lines. These sites continued to grow until the worst damage site extended across the tensile flange that caused final failure of the tension flange at 492,147 cycles. The failure site occurred at  $x = 356 \pm 5$  mm and is shown in Figures 66 and 67.

The flange damage was very localized, while the delamination of the entire flange from the I-beam preform extended from  $x = 260$  to  $x = 406$  mm and was due to the flange failure. The delamination in the beam occurred between the  $+45^\circ$  (ply 12, Table 22) and the adhesive, and between the  $\pm 45^\circ$  plies (plies 15,16, Table 22). The failure also caused delaminations to extend 16 mm down into the shear web. No shear stiffener, torsional stiffener or compression flange damage or delaminations were visible. The Instron 8501 displacement interlocks were set so that any actuator travel  $\pm 3$  mm above the nominal fatigue running displacement would stop the fatigue test and limit any post failure damage from being generated. This procedure was observed for all the beams.

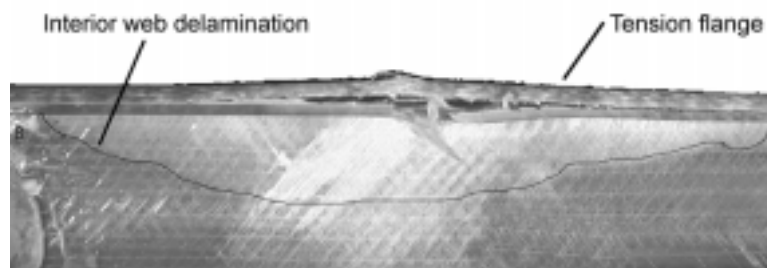
**Figure 69. Beam 8.**

At 29,051 cycles, the tensile flange failed and separated at  $x = 324 \pm 9$  mm, which caused the flange to delaminate from the preform between  $x = 255$  to  $x = 368$  mm and is shown in Figures 68 and 69. The delamination involved extensive fiber bridging between the inside flange  $+45^\circ$  (ply 12, Table 22) and the adhesive on the preform. This beam was fatigued at a higher strain than Beam 7 and thus had more internal strain energy stored in it prior to failure, which is apparent by the amount of damage generated in the web as compared to Beam 7. The web delamination extended 45 mm from the tension flange and was located at  $x = 324 \pm 44$  mm. No shear stiffener, torsional stiffener or compression flange damage or delaminations were visible.

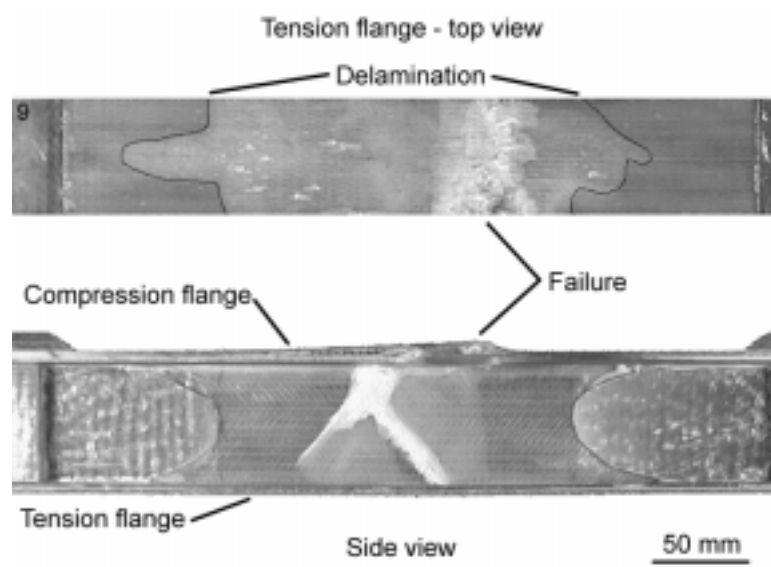
**Figure 70. Beam 9.**

Beam 9 involved a static test. The beam was loaded under actuator displacement control at a rate of 0.25 mm/s until failure, which involved a total ramp time of 43 seconds. An initial beam stiffness of 3,556 kN/m was measured. Beams 9 and 10 were constructed with the  $0^\circ$  plies on the outside (Material AA2) of the flange rather than the  $+45^\circ$  (Material AA). This layup reversal did not significantly affect the stiffness of the beam when compared to the other beams. It was apparent, after the static test, that there was substantial fiber waviness in the fabric that caused the beam to fail prematurely. Curved fiber tows, with a radius of 4 to 5 mm, turned white as they delaminated from the material around them on both the tension and compression flanges. Figures 70 and 71 show the failed beam. The ultimate load that the beam held was 59.2 kN and corresponded to a maximum tension flange strain of 1.78% and a minimum compression flange strain of -1.80%. The load versus maximum strain graph is shown in Figure 72. The buckling failure of the compression flange occurred at two sites:  $x = 260 \pm 6$  mm on the flange and  $x = 298 \pm 10$  mm on the preform. Delamination of the flange from the web flange occurred from  $x = 203$  to  $x = 419$  mm and was between the adhesive layer and  $0^\circ$  (ply 12, Table 23) ply and also between the  $0^\circ$  (ply 12, Table 23) and  $-45^\circ$  (ply 11, 23) plies. The delamination also heavily affected the web,  $x = 260$  mm to  $x = 356$  mm, as the web delaminated fully between the interior  $-45^\circ$  plies and also placed a spot delamination in the adhesive region on the tension flange. No shear stiffener, torsional stiffener or other tension flange damage or delaminations were visible.

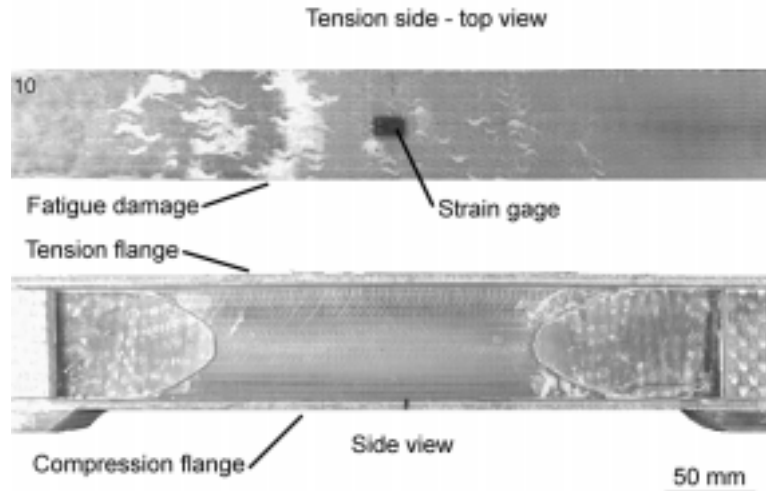
**Figure 74. Beam 10.**

Beam number 10 was fatigued at a rate of 1 Hz with a maximum load of 40.0 kN and a minimum load of 4.0 kN. The maximum load produced an initial maximum tension flange strain of 1.07% and a minimum compression flange strain of -0.97%. The initial beam stiffness was measured as 3,694 kN/m. The initial hysteresis of the beam is shown in Figure 73. As with Beam 9, the fiber waviness caused premature damage to be generated on the tension flange. The test was stopped after 1,870 cycles due to the amount of damage present on the tension flange and the white delaminated regions had reached both sides of the flange at  $x = 349 \pm 13$  mm. The beam stiffness was checked after the 1,870 cycles and equaled 3,384 kN/m, which was 92% of the initial stiffness. The failure site will probably occur at  $x = 254 \pm 12$  mm due to the amount of accumulated damage in the  $0^\circ$  plies across the tension flange. No shear stiffener, torsional stiffener or compression flange damage or delaminations were visible at the end of the test. The failed beam is shown in Figure 74.

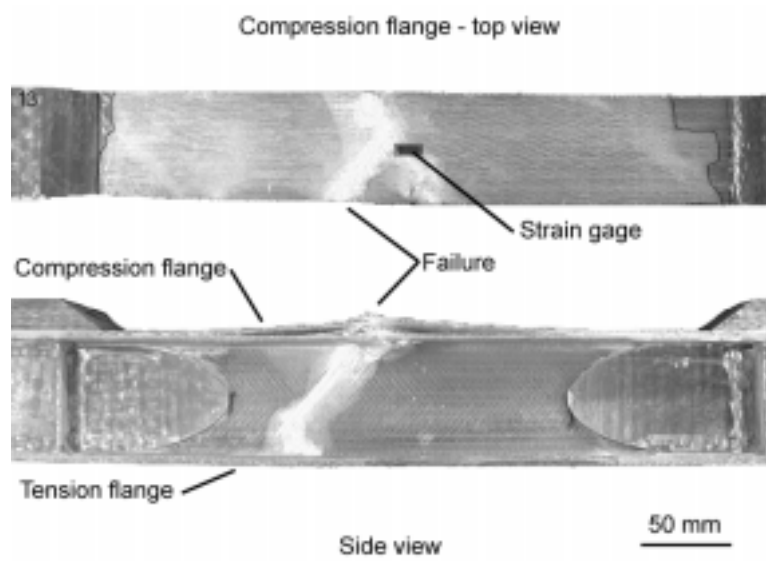
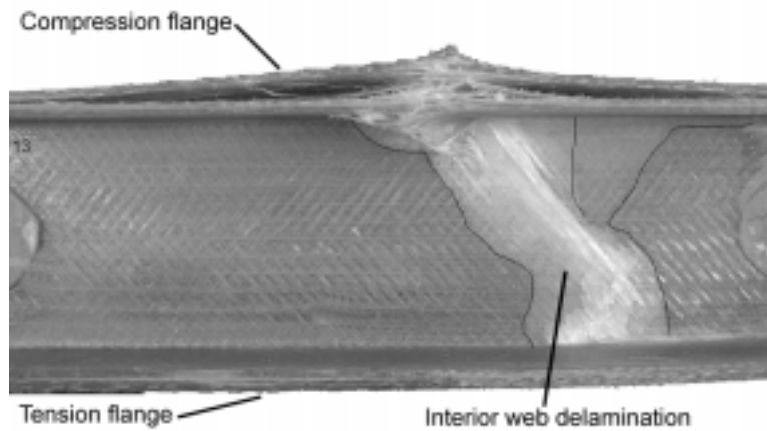
**Figure 81. Beam 13.**

Beam 13 involved a static test. The beam was loaded under actuator displacement control at a rate of 0.51 mm/s until failure, which involved a total ramp time of 21 seconds. An initial beam stiffness of 3,516 kN/m was measured. The ultimate load was 60.72 kN and corresponded to a maximum tension flange strain of 2.10%, a minimum compression strain of -1.85% and a maximum mid-span deflection of 17 mm. The load versus maximum strain graph is shown in Figure 80. The beam failed in the compression flange at  $x = 330 \pm 25$  mm with delaminations between the 0° (ply 10, Table 22) and +45 plies (ply 11, 22) over the distance of  $x = 165$  mm to  $x = 457$  mm. The failed beam is shown in Figures 81 and 82. The failure at  $x = 330$  mm caused the web to delaminate towards the tension flange under this failure point, causing an additional delamination spot under the tension flange. No shear stiffener, torsional stiffener or other tension flange damage or delaminations were visible.

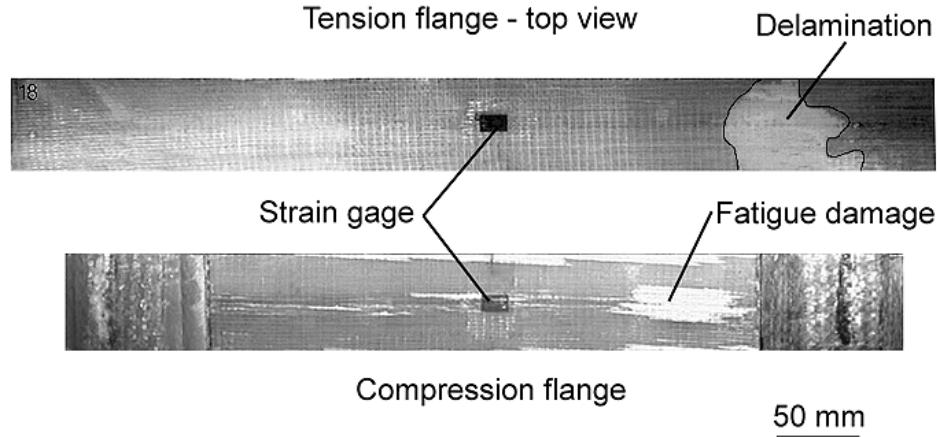
**Figure 86. Beam 18.**

Beam number 18 was fatigued at a rate of 1 Hz under sinusoidal load control with a maximum load of 62.3 kN and a minimum load of 6.3 kN. The maximum load produced an initial maximum tension flange strain of 1.42% and a minimum compression flange strain of -1.34%. The initial beam stiffness was measured as 4,134 kN/m. During the fatigue test, it was evident from the  $0^\circ$  fiber bundles delaminating from the flange surface that the DD5P flange material had been manufactured with a  $2^\circ$  to  $3^\circ$  angle. This angle caused the  $0^\circ$  edge terminated fibers to delaminate, starting from the flange edge and growing inward along the fiber bundle axis. This damage was confined to 4 to 6 mm from the flange edges and involved both the tension and compression flanges. The beam stiffness was checked throughout the test and is summarized in Table 25. As the fatigue test progressed, the tension flange started to delaminate from the C - channel between the  $0^\circ$  ply (ply 8, Table 24) and the  $+45^\circ$  ply (ply 7, Table 24). This initial delamination started in the center of the beam and was located directly above the tapered shear stiffeners,  $x = 165$  mm and  $x = 457$  mm. This delamination grew until the test was stopped after 9,367 cycles. At this point, the delamination extended from  $x = 127$  mm to  $x = 571$  mm, but had not completely traveled across the width of the flange. The compression flange had some transverse tensile cracks under the edges of the web and extended from  $x = 152$  to 457 mm. There was also major flange damage at  $x = 381$  to 432 mm, directly below the tapered shear stiffener, that was 18 mm wide. This damage involved broken  $0^\circ$  on the surface and delaminations throughout the thickness of the flange. The web had delaminations extending into the shear stiffeners, but otherwise the center web,  $x = 215$  to  $x = 394$  mm, had no other noticeable damage. One shear stiffener showed cracking at  $x = 444 \pm 12$  mm on the tension flange side and was involved with the web delamination underneath. The failed beam is shown in Figure 86.

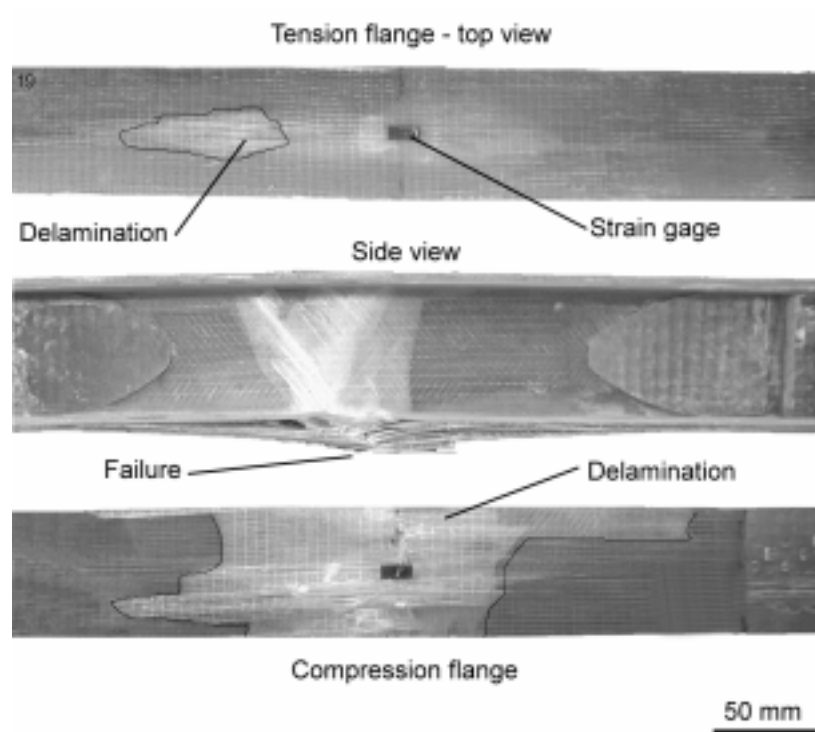
**Figure 88. Beam 19.**

Beam 19 involved a static test. The beam was loaded under actuator displacement control at a rate of 0.05 mm/s until failure, which involved a total ramp time of 208 seconds and a total mid-span deflection of 13 mm. An initial beam stiffness of 4,245 kN/m was measured. As with the other static tests, the compression flange twisted prior to final failure. This twisting was also evident in the failed beam as one side of the beam flange had fragmented glass  $0^\circ$  and  $\pm 45^\circ$  tows pointing up, while the other side of the flange had the fragmented glass tows pointing down. The compression flange failed at  $x = 305 \pm 15$  mm with multiple delaminations throughout the flange thickness. The compression flange delaminated between the  $0^\circ$  ply (ply 5, 24) and  $-45^\circ$  ply (ply 6, Table 24) from  $x = 305$  to 457 mm. The flange also delaminated between the  $0^\circ$  ply (ply 8, Table 24) and the adhesive from  $x = 158$  to 305 mm. The failure caused a delamination to travel into the web and created two spot delaminations on the tension flange in the adhesive layer. One shear stiffener showed some delamination at its tapered tip. No other shear stiffener, torsional stiffener or other tension flange damage or delaminations were visible. A maximum tension flange strain of 1.96% and a minimum compression flange strain of -1.82 %, which occurred at a ultimate applied load of 89.18 kN, is shown in Figure 87. The failed beam is shown in Figure 88.

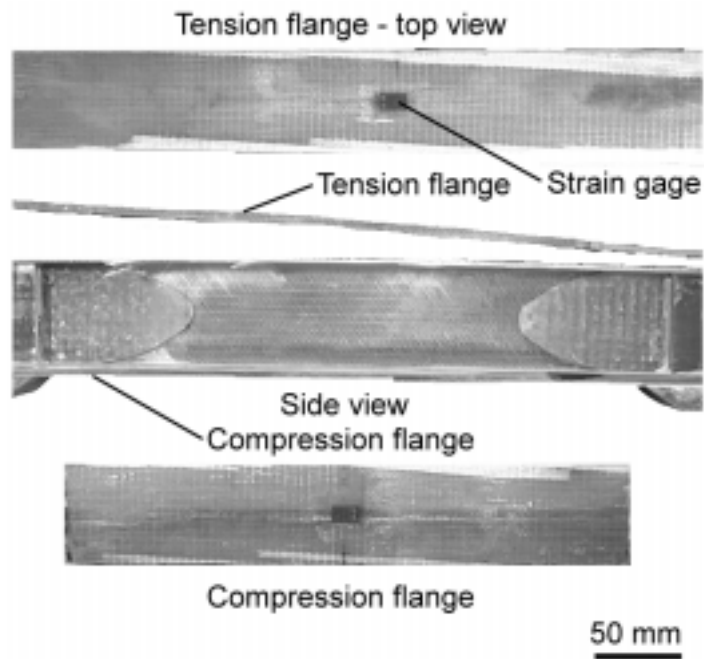
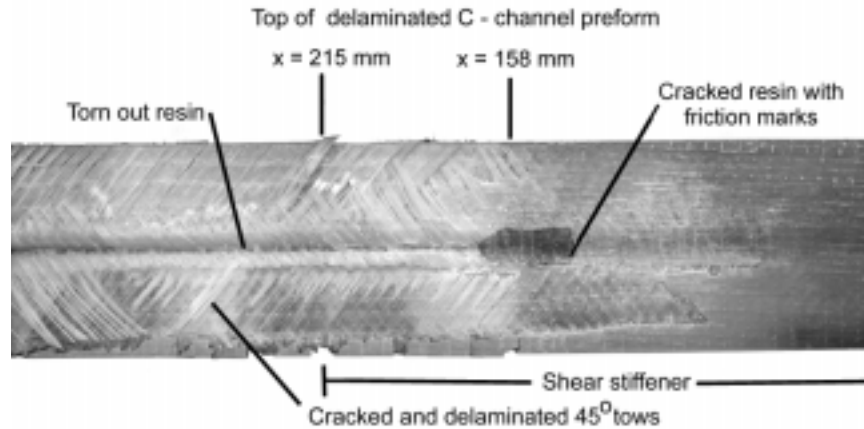
**Figure 89. Beam 20.**

Beam number 20 was fatigued at a rate of 4 Hz under sinusoidal load control with a maximum load of 53.4 kN and a minimum load of 5.3 kN. The maximum load produced an initial maximum tension flange strain of 1.09% and a minimum compression flange strain of -1.09%. The initial beam stiffness was measured as 4,218 kN/m. The beam stiffness was checked throughout the test and is summarized in Table 26. The flanges of the beam showed the same  $0^\circ$  fiber misalignment,  $2^\circ$  to  $3^\circ$ , as in Beam number 18 and affected the edges of the flanges. The beam failed after 94,391 cycles due to the tension flange delaminating from the C - channel involving the  $0^\circ$  ply (ply 8, Table 24), the adhesive layer and the  $\pm 45^\circ$  ply (ply 9, Table 24). This delamination was located between  $x =$

-75 to 521 mm. Along with the edge 0° fiber delamination, the compression flange also had transverse tension cracks from  $x = 178$  to 445 mm on the flange located beneath the outside edge of the web. The web had delaminations extending 25 mm into the web towards the compression flange. The failed beam is shown in Figures 89 and 90.

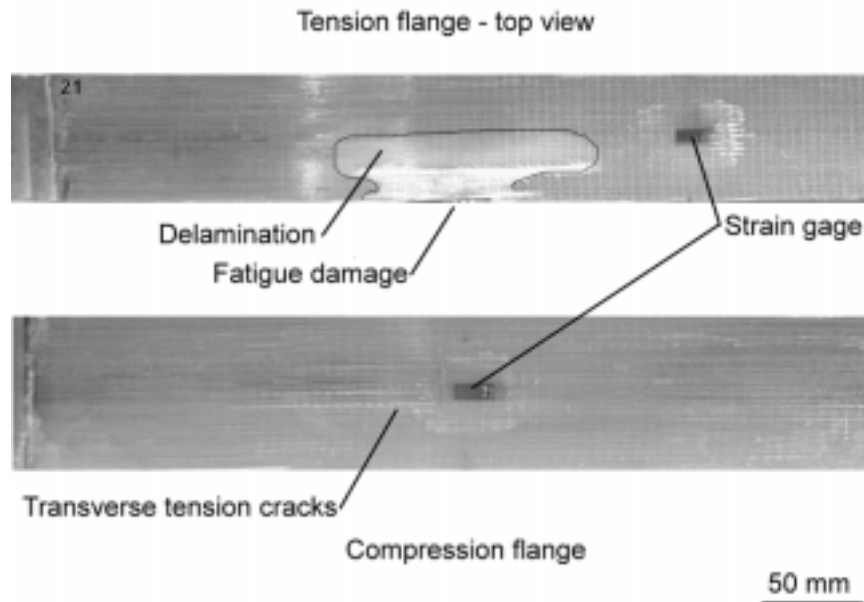
**Figure 91. Beam 21.**

Beam number 21 was fatigued at a rate of 2 Hz under sinusoidal load control with a maximum load of 53.4 kN and a minimum load of 5.3 kN. The maximum load produced an initial maximum tension flange strain of 1.14% and a minimum compression flange strain of -0.99%. The initial beam stiffness was measured as 4,110 kN/m. The beam stiffness was checked throughout the test and is summarized in Table 27. This beam had a edge flaw on the tension flange edge at  $x = 400 \pm 5$  mm and was 1 mm deep. This flaw was large enough to start flange delamination from the C - channel between the  $0^\circ$  ply (ply 8, Table 24) and the adhesive. After 23,000 cycles, the flange damage was 13 mm wide and extended from  $x = 342$  mm to 440 mm. The delamination extended towards the web and 5 mm down into it. The compression flange had some transverse tension cracks centered about the web. No shear stiffener, torsional stiffener or other compression flange damage or delaminations were visible. The beam is shown in Figure 91.

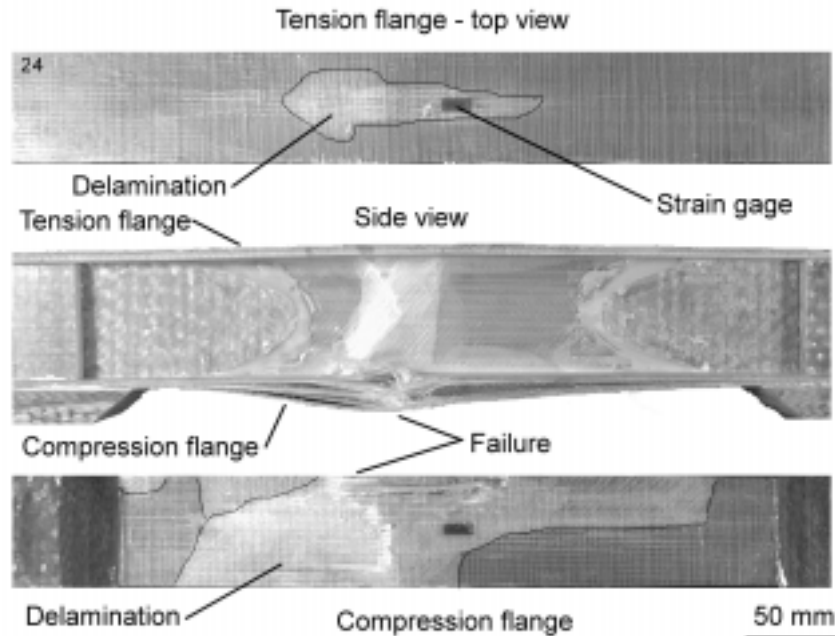
**Figure 92. Beam 24.**

Beam 24 involved a static test. The beam was loaded under actuator displacement control at a rate of 0.075 mm/s until failure, which involved a total ramp time of 190 seconds and a total mid-span deflection of 20 mm. An initial beam stiffness of 4,221 kN/m was measured. The beam had four acoustic emission sensors on the flanges: two on the tension flange centered at  $x = 76$  and 549 mm, and two on the compression flange centered at  $x = 165$  and 432 mm. A maximum tension flange strain of 1.93% and a minimum compression flange strain of -1.77% that occurred at a ultimate applied load of 88.29 kN. As with the other static tests, the compression flange twisted prior to final failure. This twisting was also evident in the failed beam as both sides of the beam flange had fragmented glass  $0^\circ$  and  $\pm 45^\circ$  tows pointing up. This was a different mode of buckling than the other beams had shown. The compression flange failed at  $x = 320 \pm 10$  mm with multiple delaminations throughout the flange thickness. The compression flange delaminated between the  $0^\circ$  ply (ply 5, Table 24) and  $-45^\circ$  ply (ply 6, Table 24) from  $x = 146$  to 437 mm. The failure caused

delaminations to travel through the web and into the tension flange adhesive layer. Transverse tension cracks were present on the tension flange from  $x = 250$  to  $458$  mm. The failed beam is shown in Figure 92. No shear stiffener, torsional stiffener or other tension flange damage or delaminations were visible.

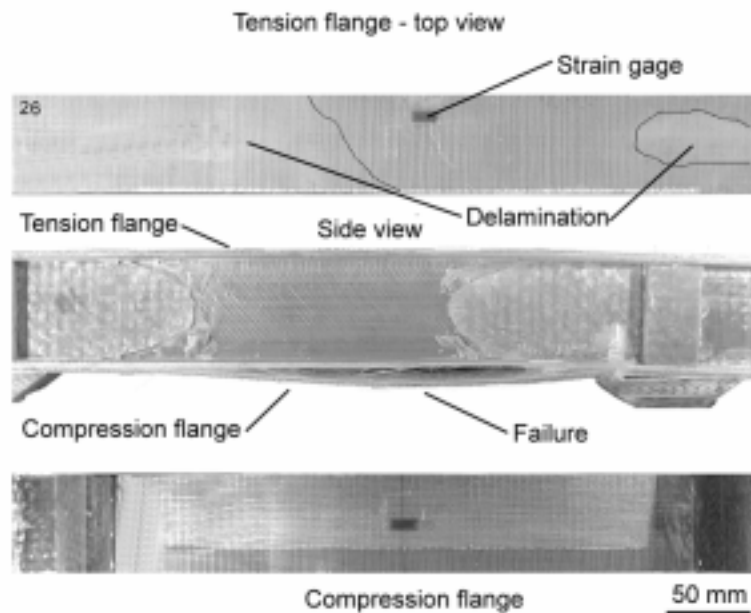
**Figure 94. Beam 26.**

Beam number 26 was fatigued at a rate of 2 Hz under sinusoidal load control with a maximum load of 57.8 kN and a minimum load of 5.8 kN. The maximum load produced an initial maximum tension flange strain of 1.22% and a minimum compression flange strain of -1.05%. The initial beam stiffness was measured as 4,355 kN/m. The beam stiffness was checked throughout the test and is summarized in 28. After 104,407 cycles, the beam failed by compression flange delamination and shear stiffener failure. Shear failure of the compression flange occurred at  $x = 133$  mm. This was under the compression flange load pad. The compression flange delaminated between the  $0^\circ$  ply (ply 8, 24) and the adhesive layer. Delamination of the tension flange above the shear stiffeners,  $x = 178$  and  $428$  mm, was noticed at 10,000 cycles and continued to grow until failure. The beam is shown in Figure 94. All shear stiffeners showed some signs of delamination from the web.

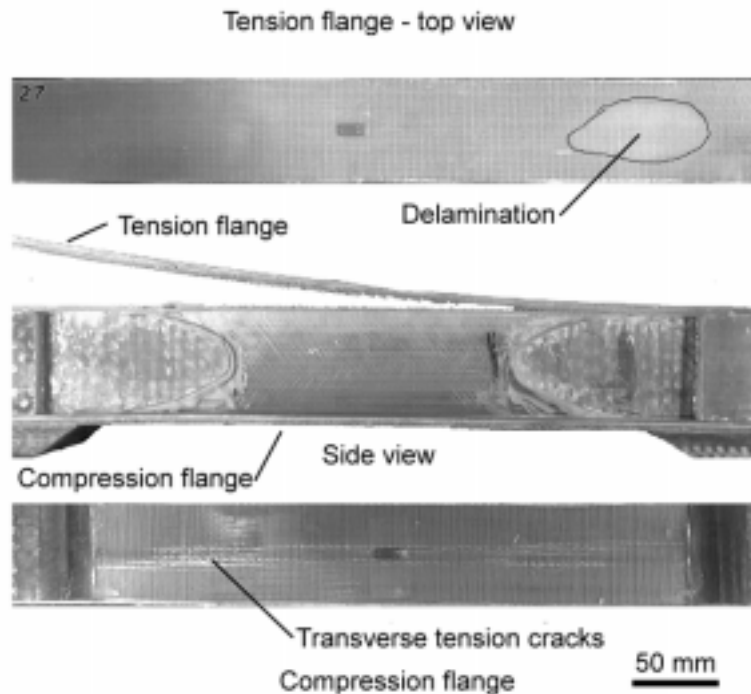
**Figure 95. Beam 27.**

Beam number 27 was fatigued at a rate of 3 Hz under sinusoidal load control with a maximum load of 53.4 kN and a minimum load of 5.3 kN. The maximum load produced an initial maximum tension flange strain of 1.07% and a minimum compression flange strain of -1.00%. The initial beam stiffness was measured as 4,069 kN/m. As with the other DD5P beams, two tension flange delamination spots started over the tapered shear stiffener area,  $x = 178$  and  $445$  mm. These spots grew during the fatigue test until the delamination was under a tension flange load pad. After 243,876 cycles, the tension flange delaminated. The delamination involved the adhesive layer and the adjacent  $0^\circ$  and  $45^\circ$  plies and was from  $x = -75$  to  $483$  mm. Some transverse cracks were present on both the tensile and compression flanges prior to failure. The shear stiffeners under the delamination show some damage, but it is not known if this was present prior to failure. The web also has delaminations extending 15 mm down towards the compression flange. The failed beam is shown in Figure 95.

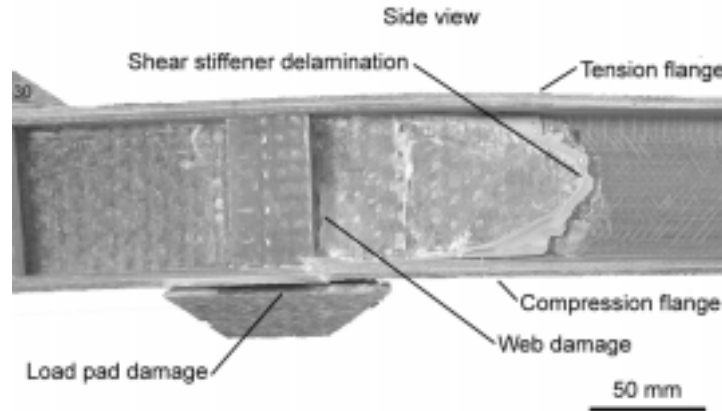
**Figure 99. Beam 30.**

Beam number 30 was fatigued at a rate of 2 Hz under sinusoidal load control with a maximum load of 62.3 kN and a minimum load of 6.2 kN. The maximum load produced an initial maximum tension flange strain of 1.20% and a minimum compression flange strain of -1.05%. The initial beam stiffness was measured as 4,345 kN/m. The beam had four acoustic emission sensors on the flanges: two on the tension flange centered at  $x = 64$  and 533 mm, and two on the compression flange centered at  $x = 178$  and 432 mm. After 5,741 cycles, the test was stopped as the failure mode was identical to Beam number 26. The shear stiffeners had delaminated and the compression flange had a shear failure through its thickness at  $x = 120$  mm, under a compression flange load pad. The shear stiffener had a crack at  $x = 120$  mm, which was the start of the stiffener taper, 30 mm up towards the tension flange. The compression flange had a few transverse tension cracks. The tension flange had started to delaminate over the shear stiffeners. No torsional stiffener or other tension flange damage or delaminations were visible. The failed beam is shown in Figures 98 and 99.

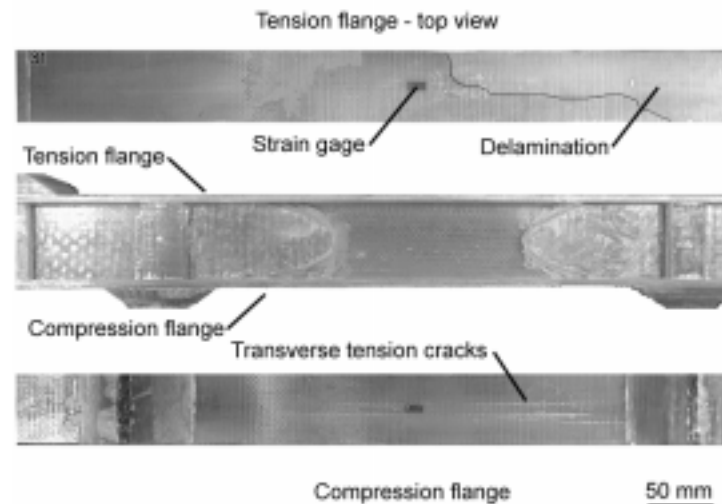
**Figure 100. Beam 31.**

Beam number 31 was fatigued at a rate of 4 Hz under sinusoidal load control with a maximum load of 53.4 kN and a minimum load of 5.3 kN. The maximum load produced an initial maximum tension flange strain of 1.92% and a minimum compression flange strain of -0.89%. The initial beam stiffness was measured as 4,764 kN/m. The stiffness was also checked after a power outage at 796,633 cycles, 4,170 kN/m and after 2,030,240 cycles 3,248 kN/m. The test was stopped after 2,030,240 cycles. After these cycles 3 of the shear stiffeners had started to delaminate from the web and the tension flange had delaminated from the C - channel between  $x = 25$  and 280 mm. There was also web delamination damage at  $x = 195$  mm that extended down from the tension flange into the tapered shear stiffener area. The compression flange also had multiple transverse tension cracks under this shear stiffener area. The beam is shown in Figure 100.

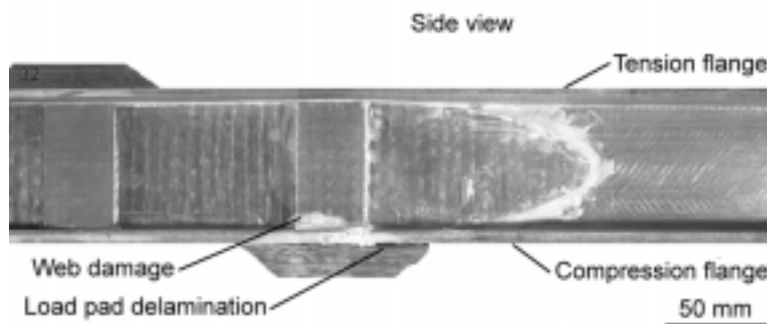
**Figure 101. Beam 32.**

Beam number 32 was fatigued at a rate of 5 Hz under sinusoidal load control with a maximum load of 53.4 kN and a minimum load of 5.3 kN. The maximum load produced an initial maximum tension flange strain of 0.86% and a minimum compression flange strain of -0.73%. The initial beam stiffness was measured as 4,639 kN/m. The beam stiffness was checked throughout the test and is summarized in Table 30. The fatigue test was stopped after 783,153 cycles. Like Beams 26 and 30, this beam started to have the same failure mode. The compression flange has sheared through the thickness at  $x = 127$  mm under a compression flange load pad at the edge of the torsional stiffener. The compression flange did not have any visible transverse tension cracks. The only other damage on the beam was the spot delaminations on the tension flange over the shear stiffeners. The beam is shown in Figure 101.

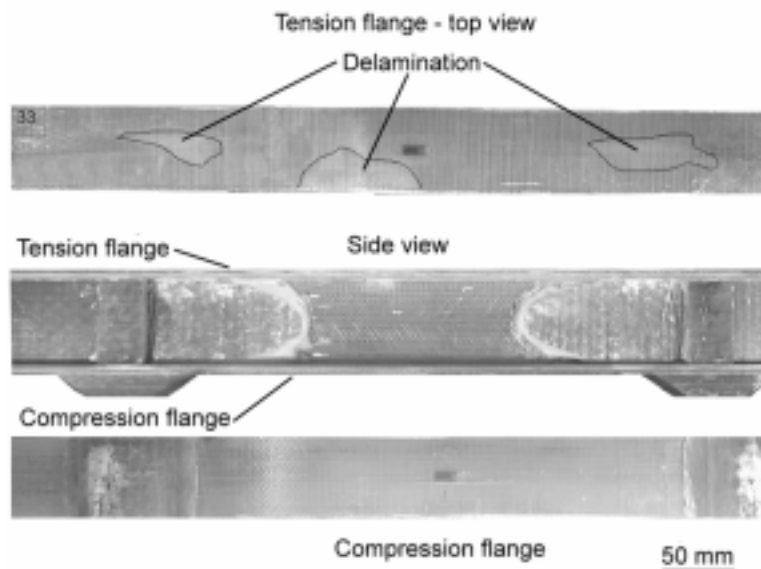
**Figure 102. Beam 33.**

Beam number 33 was fatigued at a rate of 4 Hz under sinusoidal load control with a maximum load of 53.4 kN and a minimum load of 5.3 kN. The maximum load produced an initial maximum tension flange strain of 0.94% and a minimum compression flange strain of -0.93%. The initial beam stiffness was measured as 4,606 kN/m. The beam stiffness was checked throughout the test and is summarized in Table 31. The beam was stopped after 3,200,000 cycles. Although the beam had not failed, there was some tension flange delamination, three spots, which were growing and extended down into the C - channel at  $x = 318$  mm. The compression flange had some minor transverse tension cracks. The beam is shown in Figure 102.
